**IFCA-G-015**  
Valencia, CA 91355  
Fax: (818) 291-0339  
Web: [www.hyetechllc.com](http://www.hyetechllc.com)

## **6889700HT Power Train Drive Helical Gear**

**Subject:** Removal, cleaning, inspection, rework, repair, and installation procedures for 6889700HT- Power Train Drive Helical Gear

**Compliance:** Anytime the Power Train Drive Helical Gear is removed.

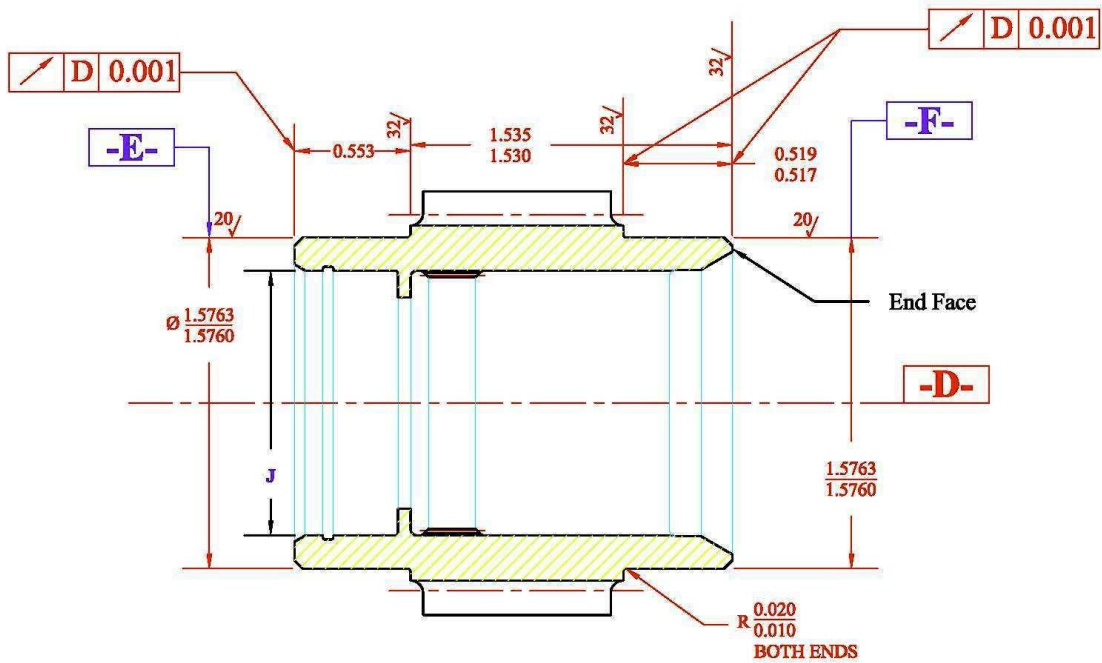
**Figure 1**

Condition	Service Limit	Repair Limit	Corrective Action
Shaft O.D. (Dia. <b>E</b> & <b>F</b> )	1.5760/1.5763 inch	1.5760/1.5763 inch	Copper plate dia. <b>E</b> & <b>F</b> per AMS-2418. Plating thickness to be 0.0001-0.0004 (See Figure 1).
Housing I.D. (Dia. <b>J</b> )	1.2604/1.2609 inch	1.2604/1.2609 inch	Copper plate per AMS-2418. Dia. <b>J</b> to show complete coverage to 0.0004 max. plating thickness on designated areas. Optional to plate radii & shoulders adjacent to dia. <b>E</b> , <b>F</b> , & <b>J</b> to 0.0004 max. plating thickness (See Figure 2).

Features shall be concentric & square within the TIR specified by **D**

- 5.1.8 Check concentricity and finish to ensure that they are within limits in Figure 1.
- 5.1.9 Bake at  $275^{\circ}\text{F}$  for five hours. The bake cycle is required on journals which are both electroless nickel and copper plated and on journals which are copper plated only.
